Water Resources Department

May 30, 2017

Re: Crowley Dam (C 10) – Special dam safety notice

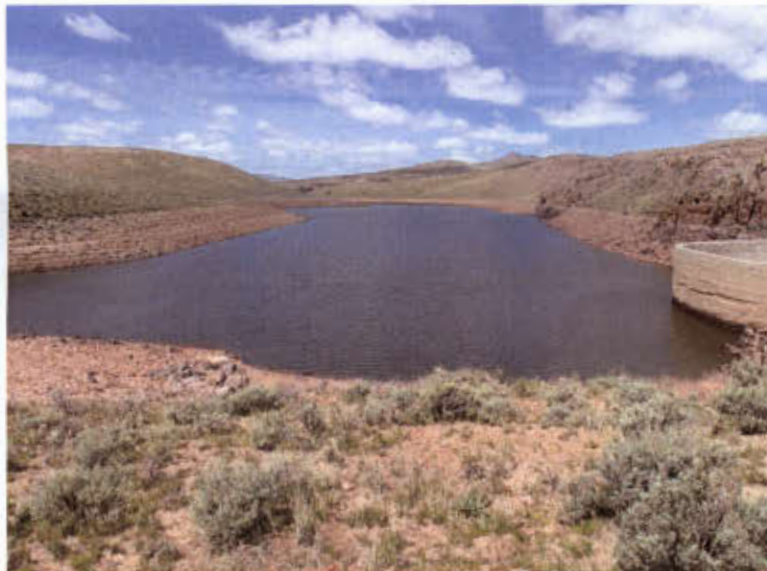
Crowley reservoir on 5-2-17

The reservoir level was about 35 feet below the dam crest when inspected. Early this year, water had flowed over the crest of the dam for about a month. A full reservoir

results in hydraulic forces on the dam, and any offset in cracking could result in catastrophic failure.

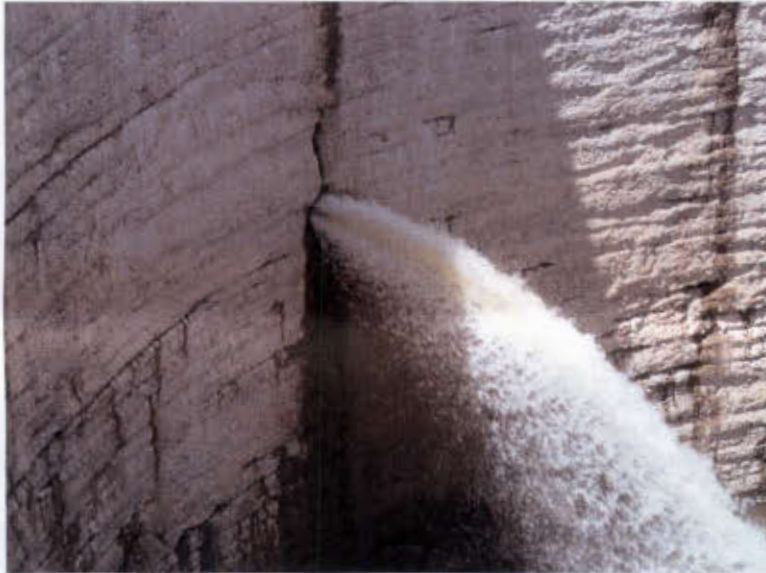
Hole through dam appears larger

As noted in the last two inspection reports, the dam is no longer serviceable. Crowley dam has been allowed to deteriorate over the course of many years. The most significant changes to the dams' condition since the last inspection are the enlargement of the hole associated with a significant vertical crack in the face of the dam.

Necessary Action: I would consider an engineered design a temporary repair that includes a time frame that the repair may be used. I would only consider a repair plan that is developed by and stamped by a professional engineer registered in Oregon. A list of potential engineers was e-mailed to you on May 9th of this year. **No later than June 20, 2017, send me the name of the engineer that will be working for you on this dam.** If an engineer is unable to develop a safe repair, valve removal is the only means of reducing risk at this dam. **If the valves cannot be opened, they should be cut off with a torch to keep them as open pipes through the dam.**

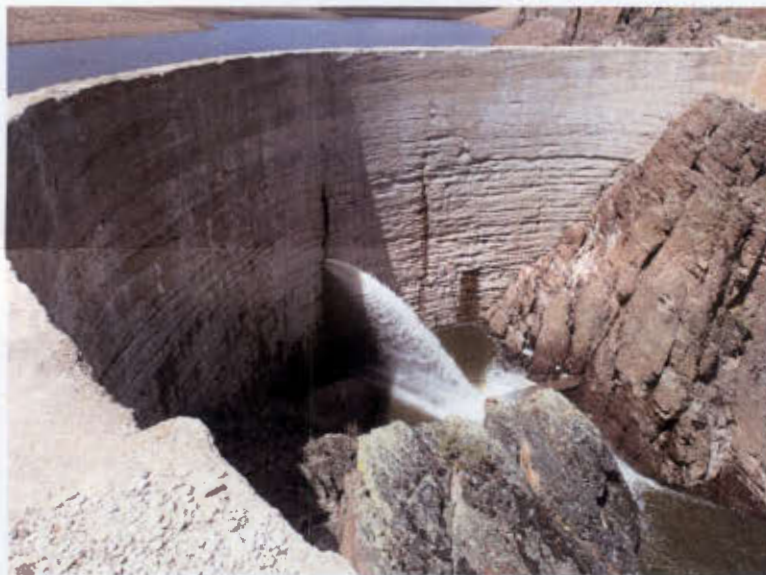
Downstream face showing cracks and leaks

As another reminder, concrete arch dams are likely to fail suddenly, catastrophically, and without warning. Removal of Crowley dam will be needed very soon even if short term repairs are possible. The two valves to control flow through the dam are below and

obscured by the leak, and are both inoperable. Unless a short term repair is designed by an engineer and completed very quickly, the valves need to be modified so that they remain fully open. Open pipes will greatly reduce the risk of the reservoir filling. It remains of critical importance to prevent water building up a hydraulic load on the arch of the dam where any movement could cause failure. Persons below the dam, including anyone in your house or on the road below the dam are at significant risk when the reservoir behind the dam is full.
